NEW KERNSVILLE DAM, BERKS COUNTY,
PENNSYLVANIA

NDS I.D. NO. PA 00723
DER I.D. NO. 6-434

PHASE I INSPECTION REPORT
NATIONAL DAM INSPECTION PROGRAM

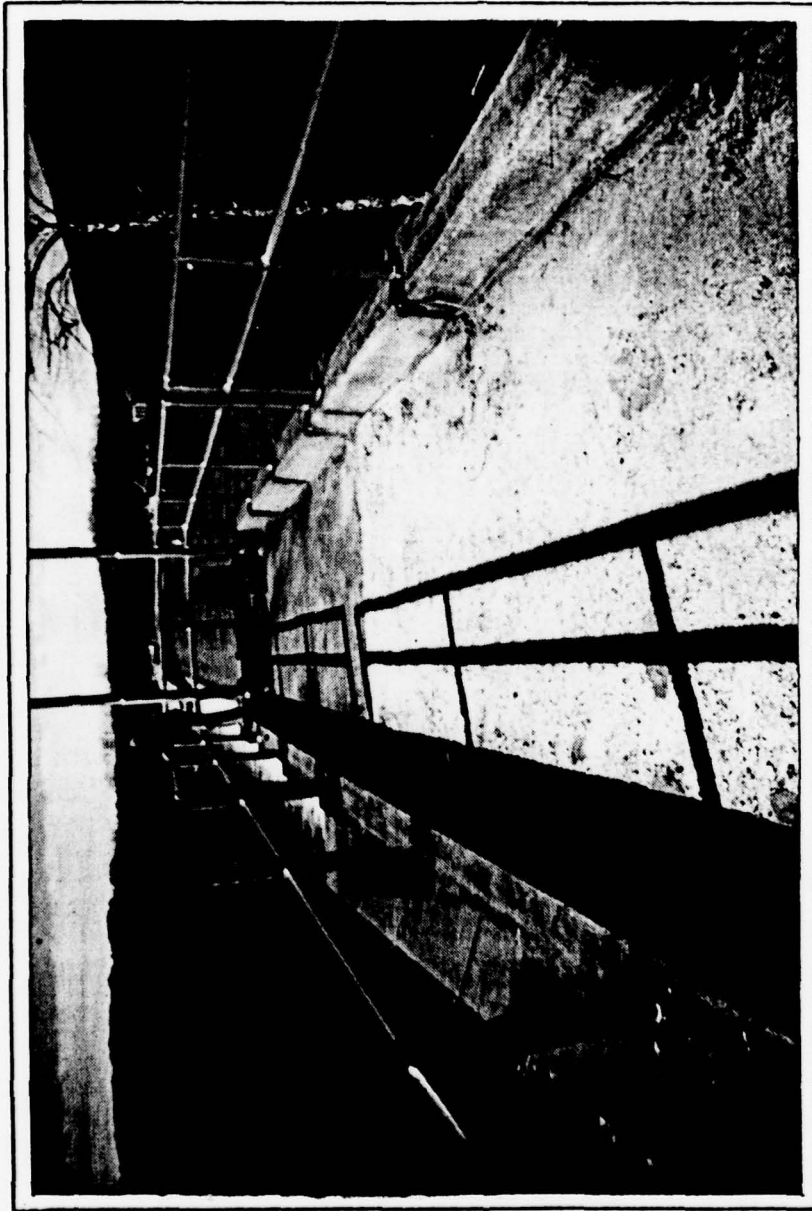
PHOTOGRAPH NO. 2

2. Nonoverflow Sections. Nonoverflow sections at each abutment were inspected and found to be in good condition, as shown in Photographs 2, 5 and 6. Some minor cracking and joint deterioration is occurring, as shown in Photographs 9 and 10, but this has no effect on the structural integrity of the section.

OBSERVATION PLATFORM ON LEFT SIDE
OF RIVER. NOTE SPALLED CONCRETE
SURFACE OF WALKWAY.

a. Facilities. The bucket area along the downstream toe of the spillway should be periodically inspected, especially after periods of high flows to check for scour or deterioration of the downstream toe. Joint deterioration at monolithic sections and below the walkway and nonoverflow section should be periodically inspected. If deterioration of these zones becomes excessive, they should be cleaned and patched.

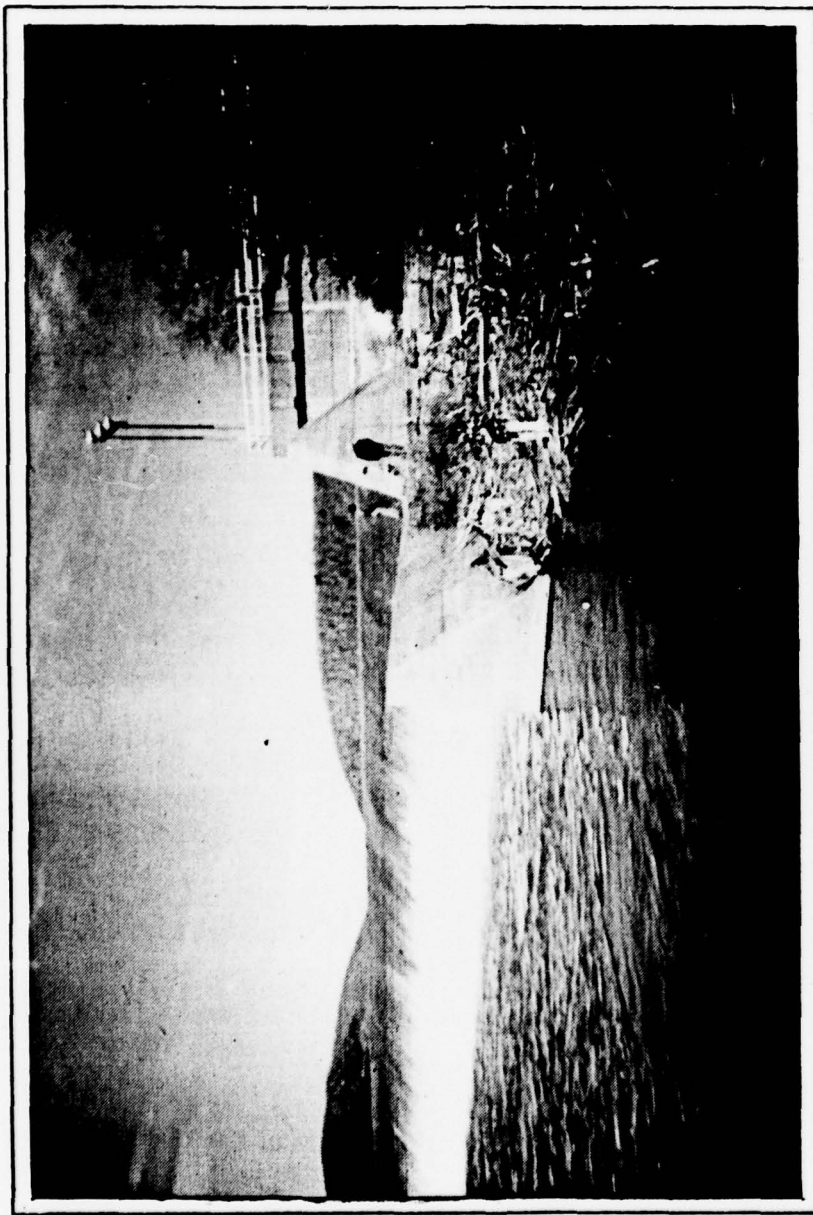
PHOTOGRAPH NO. 3

VIEW OF LEFT ABUTMENT LOOKING UPSTREAM.
NOTE DEBRIS ON INSIDE OF ABUTMENT.

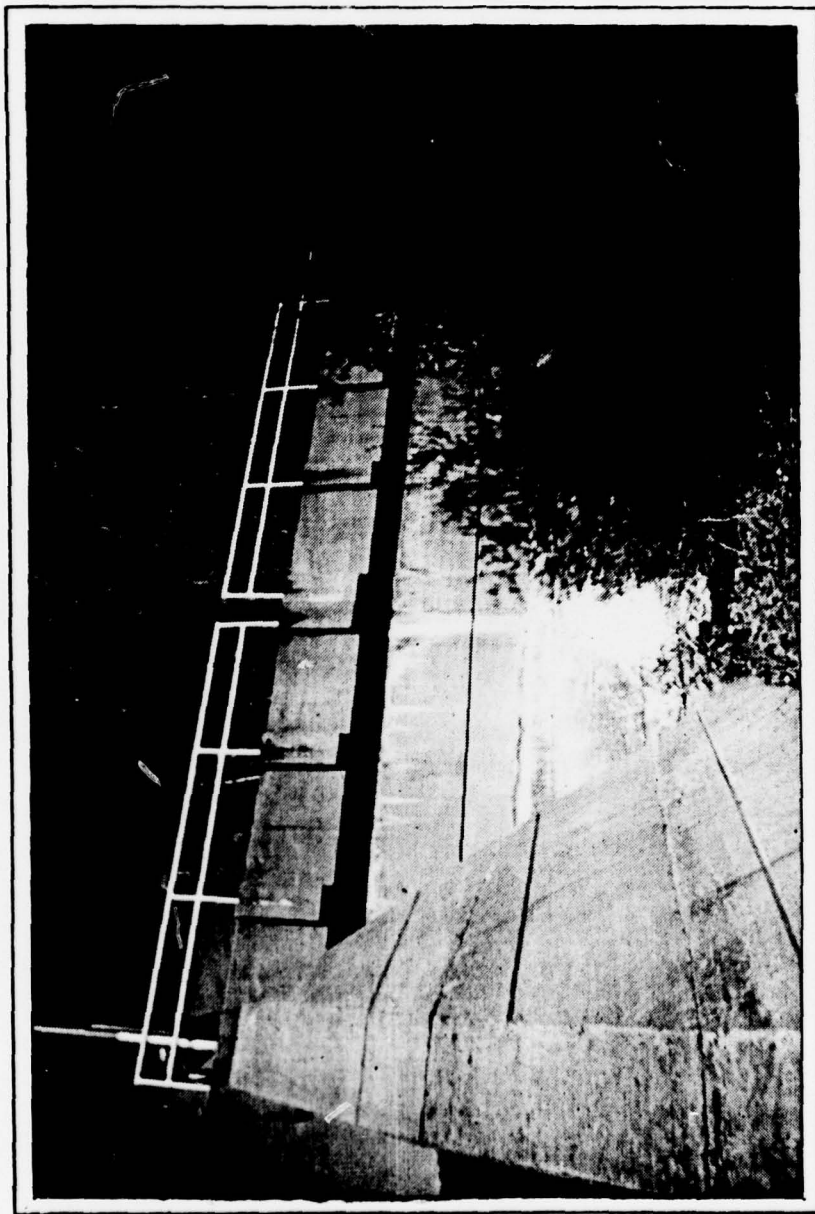
PHOTOGRAPH NO. 5

OVERVIEW OF LEFT ABUTMENT.

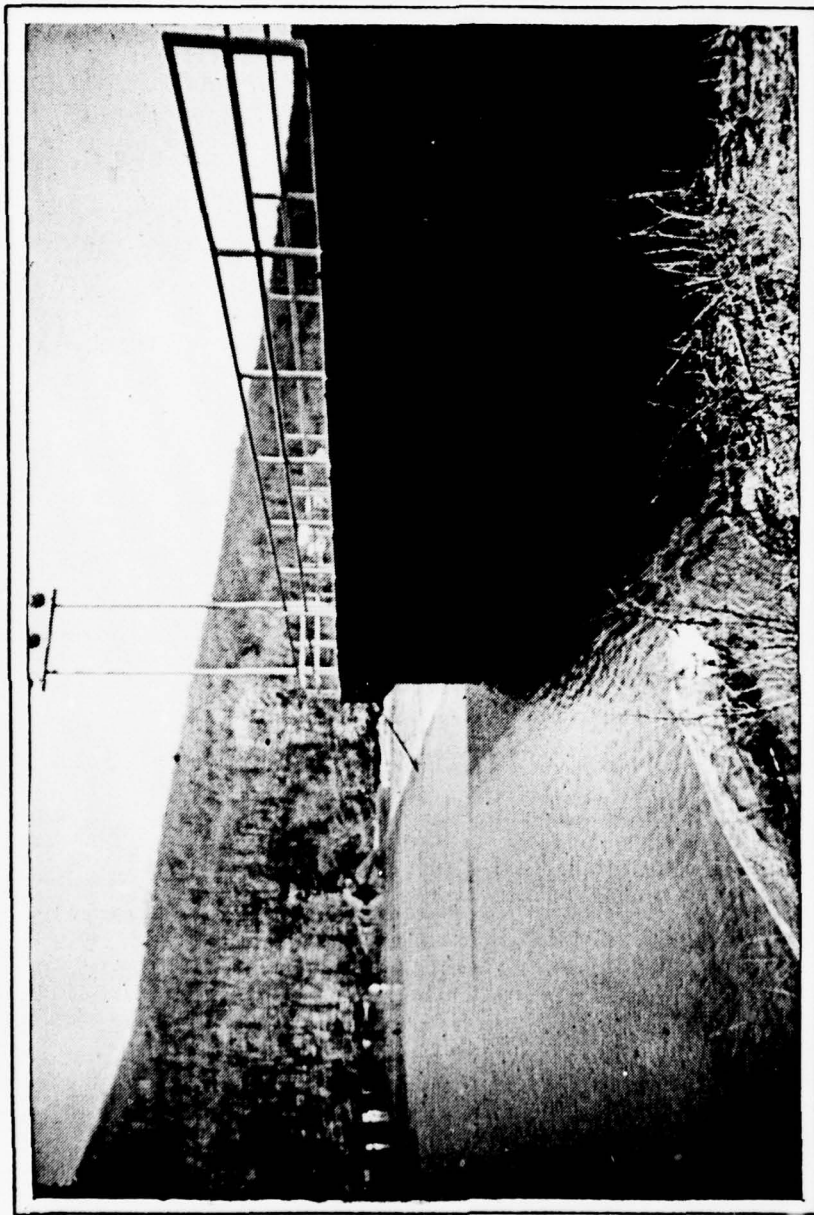
PHOTOGRAPH NO. 6

OVERVIEW OF RIGHT ABUTMENT FROM THE
UPSTREAM SIDE.

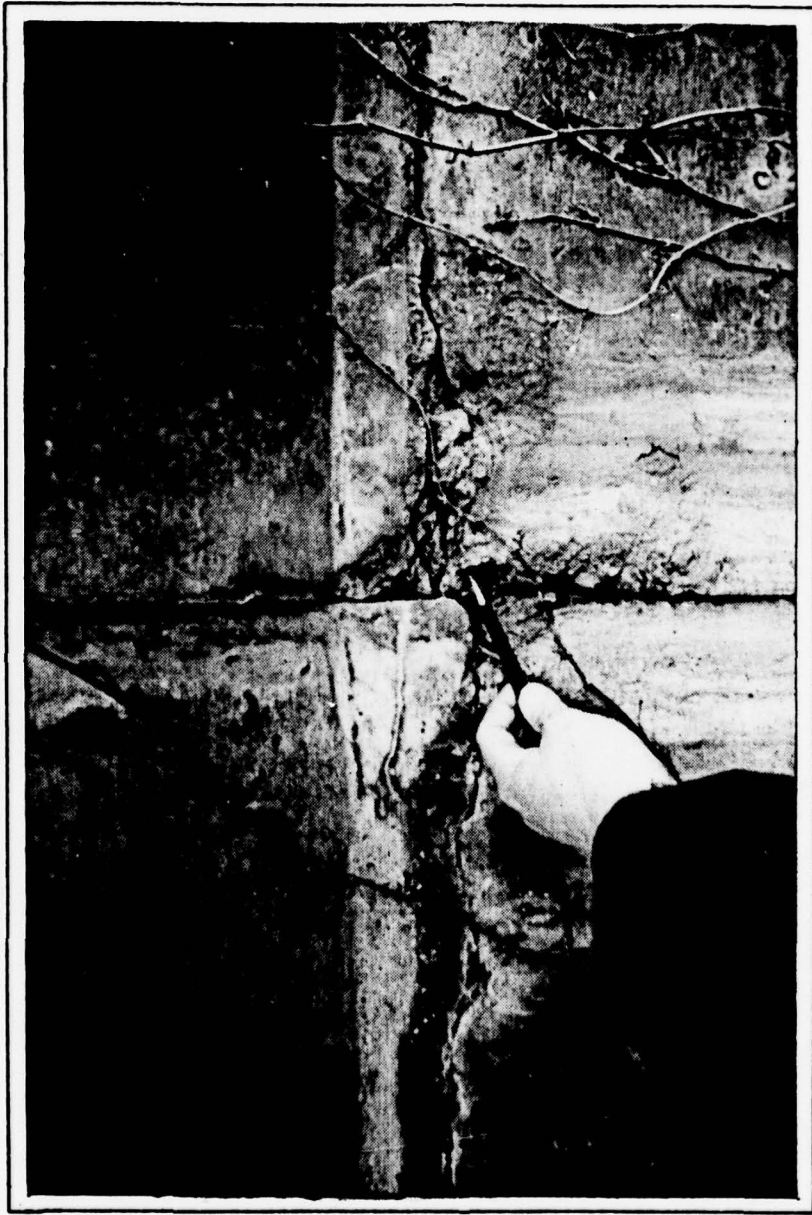
PHOTOGRAPH NO. 10

TYPICAL CONDITION OF ABUTMENT
CONSTRUCTION JOINTS.
